Effect of FRCM Repair on the Bond Behavior of Corroded Reinforced Concrete
Beams Subjected to Static and Cyclic Loading

A THESIS
SUBMITTED TO THE FACULTY OF
UNIVERSITY OF MINNESOTA
BY

IN PARTIAL FULFILLMENT OF THE REQUIREMENTS
FOR THE DEGREE OF
MASTER OF SCIENCE

August 2017

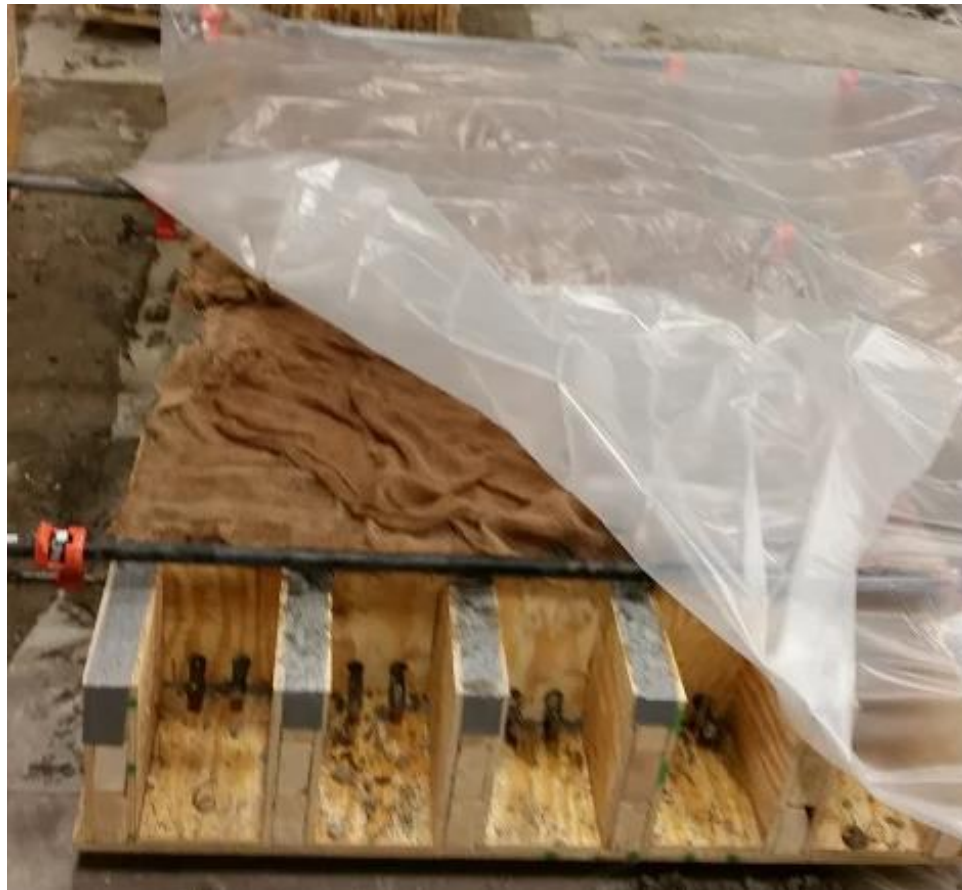
Figure 3.11: Concrete Curing with Burlap and Plastic

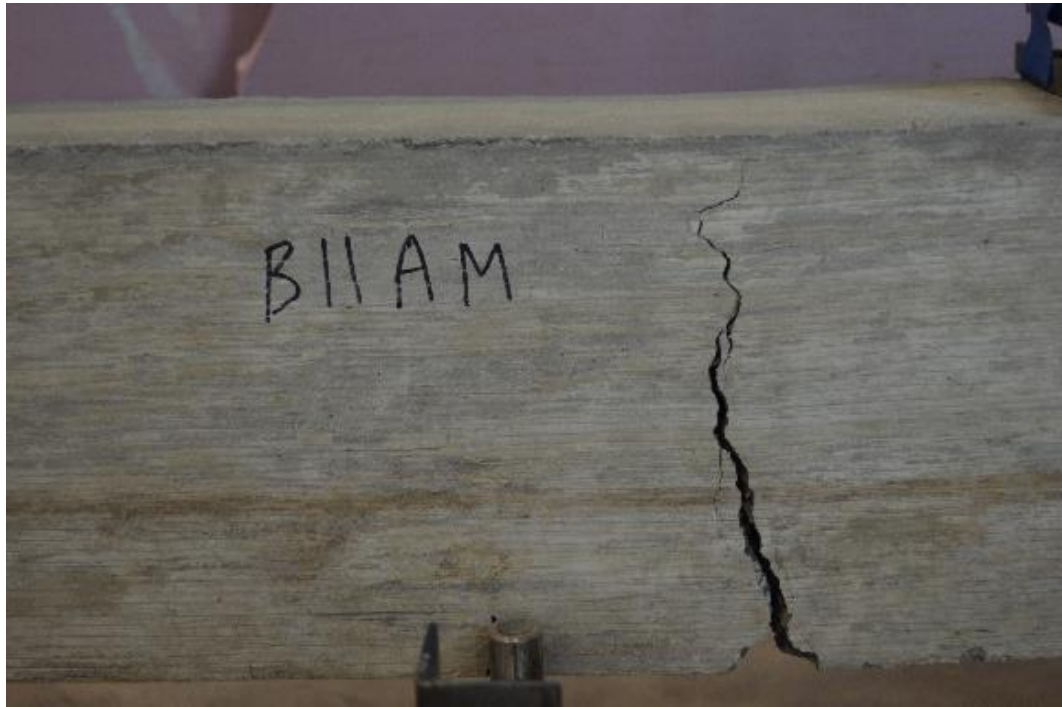
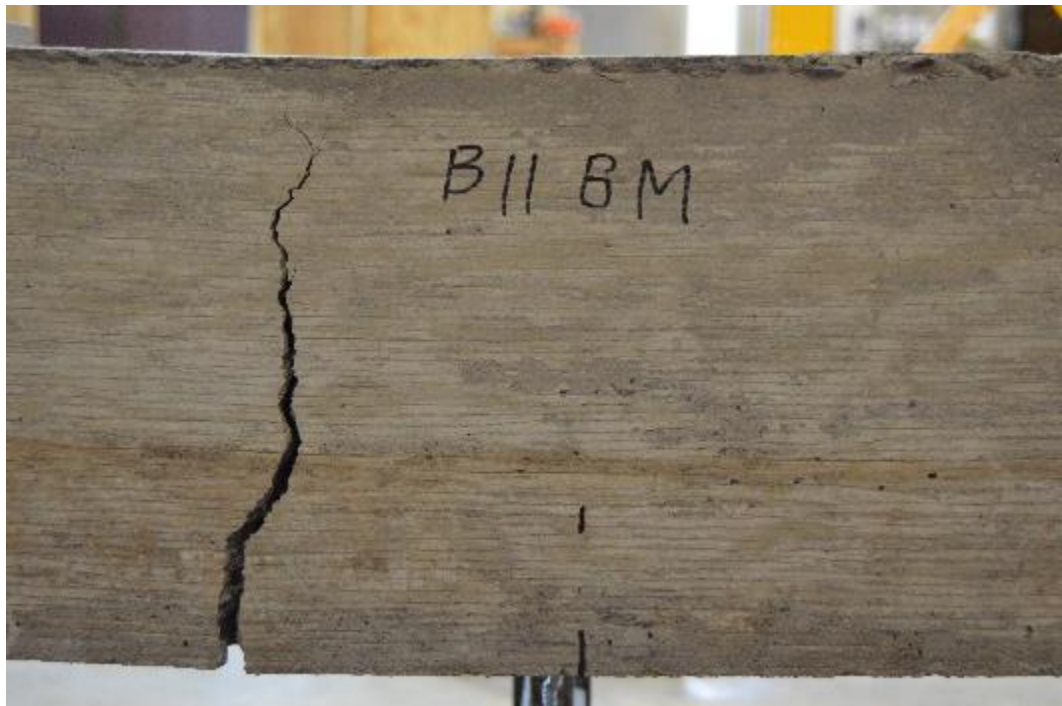
Beam H-U-S-1, mild corroded and unrepaired, was tested monotonically to failure. A flexural crack formed to the right of midspan (Figure D.6 and Figure D.7) at roughly 4.5 kips and midspan deflection of 0.03 in. Shear cracks formed on both sides of the beam at the left support around 9 kips. The load peaked at 10.1 kips and midspan deflection of 0.17 in. The shear cracks continued to grow until the bars slipped significantly, hitting the limit and preventing the test from reaching 60% of the peak load. The midspan deflection was 0.729 in. at the end of the test. The beam failed in a combination shear and splitting bond failure (Figure D.8 and Figure D.9).

Figure D.6: Flexural crack at mid-span of Beam H-U-S-1 (Side A)

Figure D.7: Flexural crack at midspan of Beam H-U-S-1 (Side B)

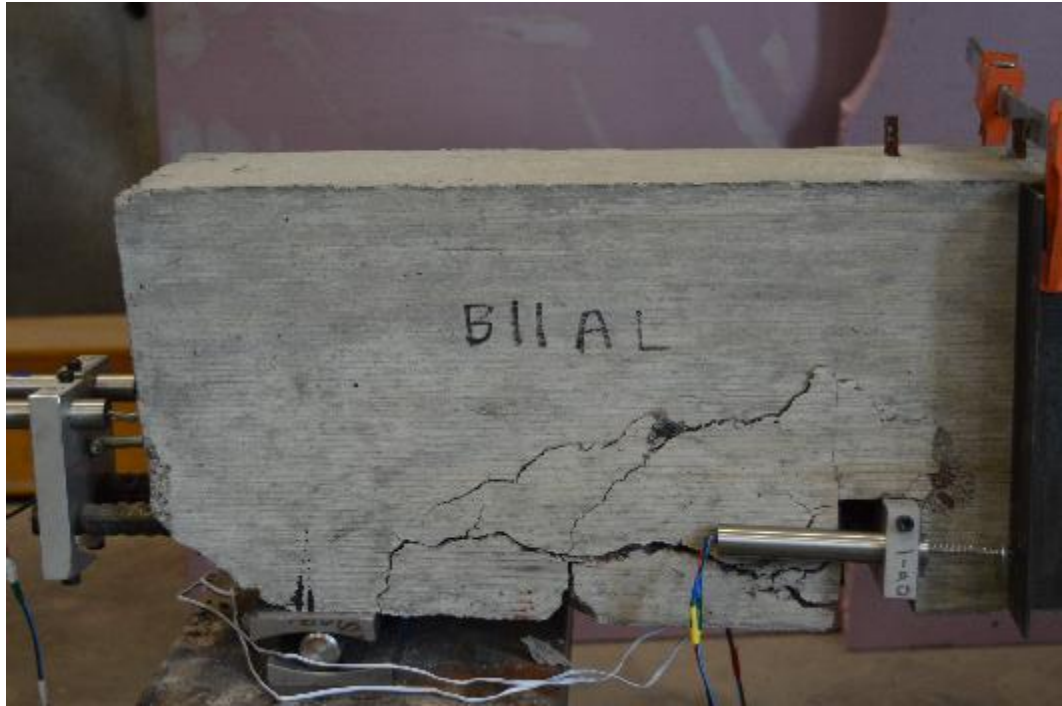
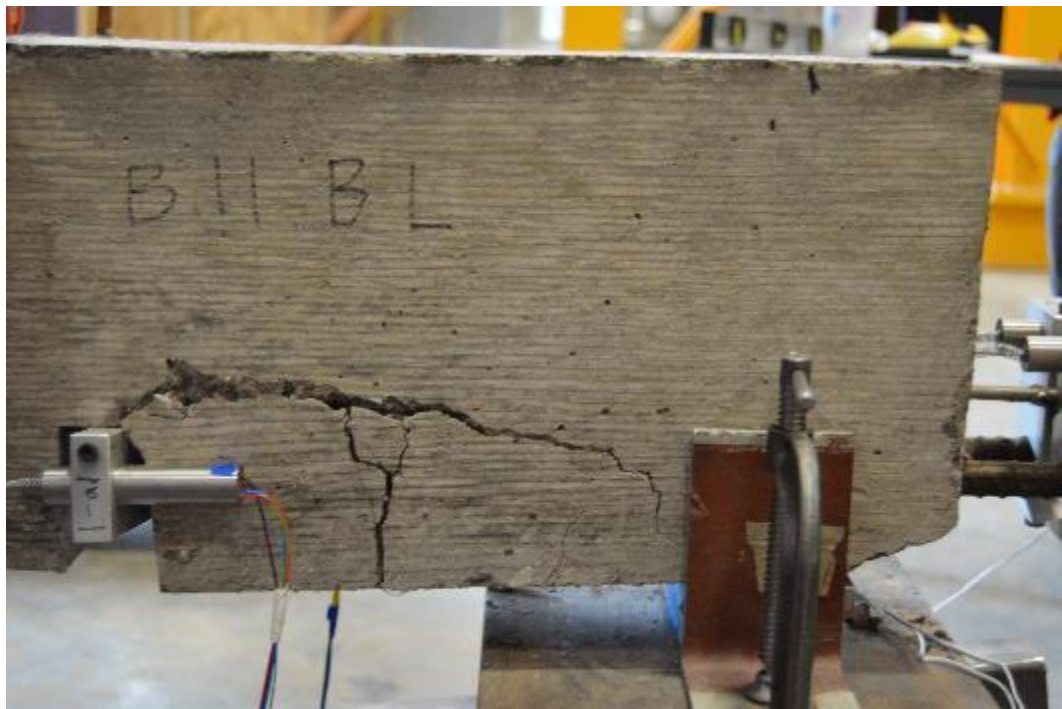
Figure D.8: Shear/splitting bond failure at right support of Beam H-U-S-1 (Side A)

Figure D.9: Shear/splitting bond failure at right support of Beam H-U-S-1 (Side B)

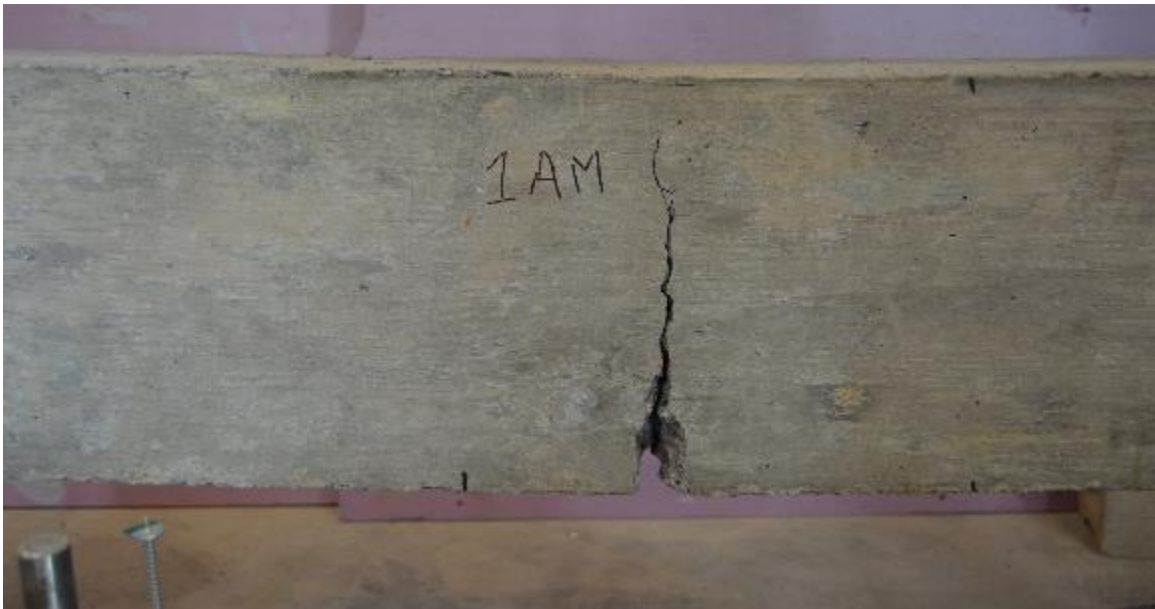
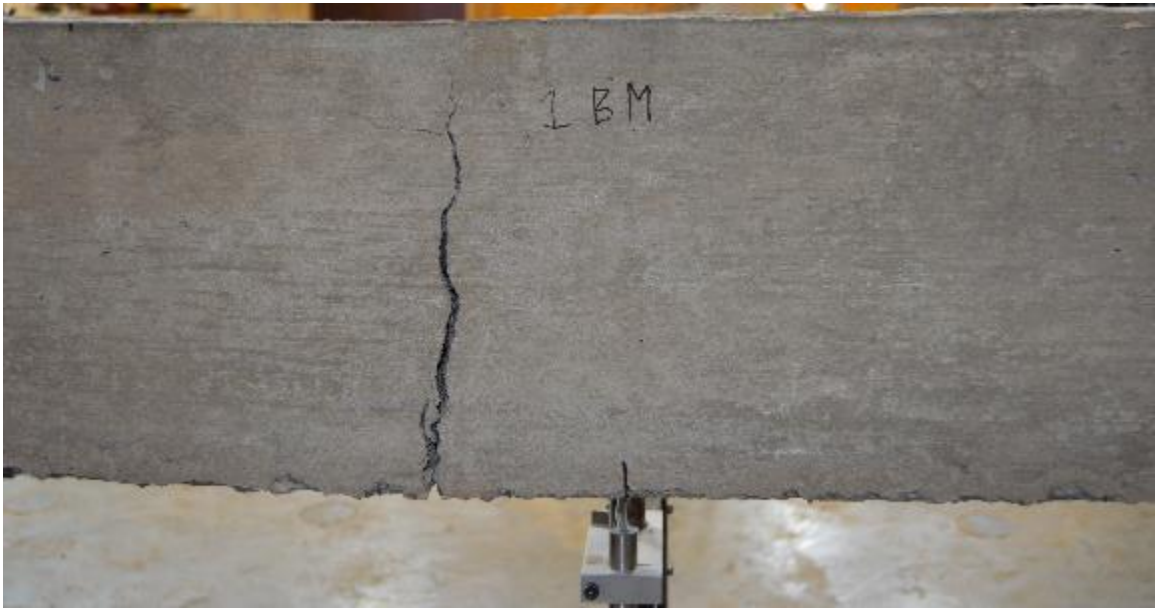
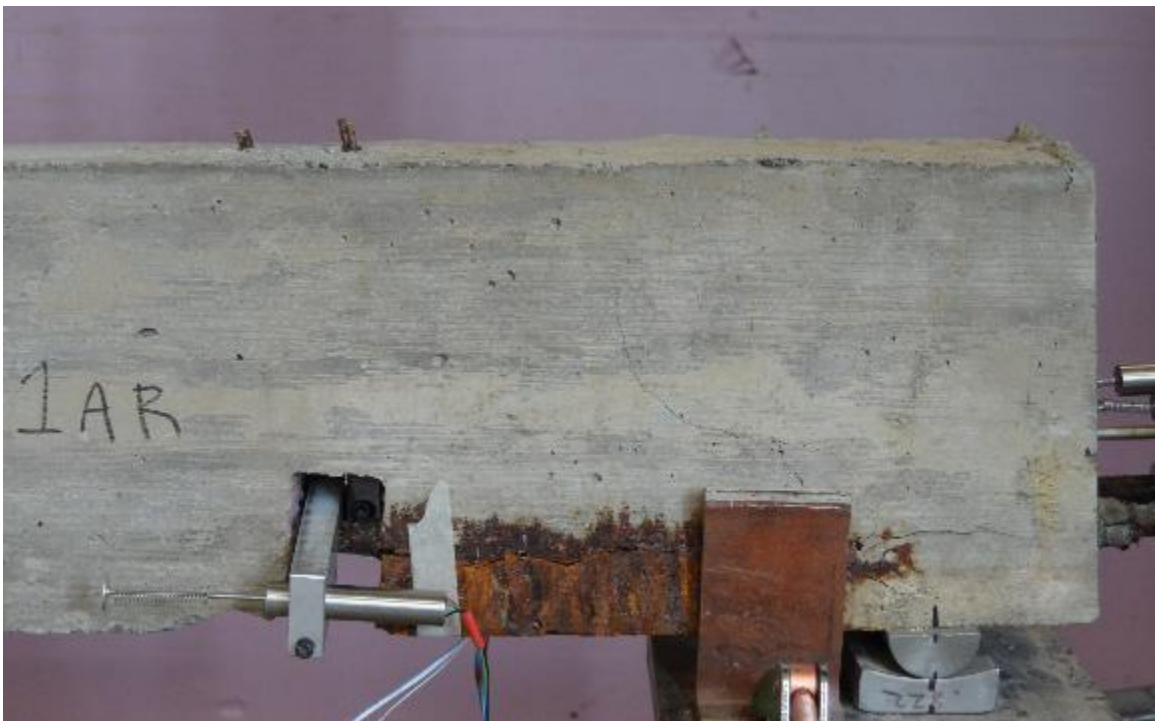
Beam H-U-S-2, high corroded and unrepaired, was tested monotonically to failure. A shear crack formed in side B at the right support (Figure D.13) at around 4 kips and 0.015 in. midspan deflection. A flexural crack formed to the right of midspan (Figure D.10 and Figure D.11) at around 6.5 kips and 0.1 in. midspan deflection. The shear crack continued to grow in side B of the right support. The load peaked at 13.54 kips and midspan deflection of 0.25 in. At this time, a shear crack became visible on side A of the right support (Figure D.12), as well as both sides of the left support (Figure D.14 and Figure D.15). The shear crack at the left support ended up growing larger than the right support. The test was stopped when the load reached 60% of the peak load. The midspan deflection was 0.665 in. at the end of the test.

Figure D.10: Flexural crack at mid-span of Beam H-U-S-2 (Side A)

Figure D.11: Flexural crack at midspan of Beam H-U-S-2 (Side B)

Figure D.12: Shear crack at right support of Beam H-U-S-2 (Side A)

Figure D.13: Shear crack at right support of Beam H-U-S-2 (Side B)

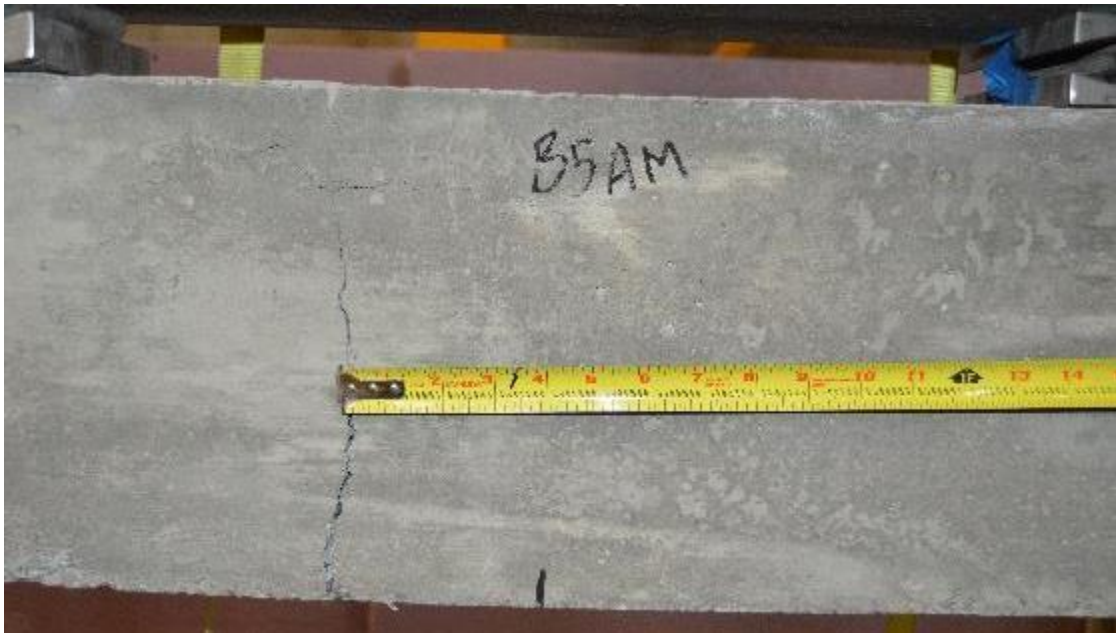
Beam N-R1-S, high corroded and unrepaired, was tested monotonically to failure. A flexural crack formed to the left of midspan (Figure D.16) at around 5.5 kips. The first drop in the load at 20 kips and 0.2 in midspan deflection was from the bars on the left end slipping slightly. Shortly after the first drop, a crack formed in the cementitious mortar of the repair at the right support causing another drop in load. This indicates cracking of the beam beneath the repair that are propagating through the mortar. After the second drop, the load continued to increase up to the peak load of 22.44 kips. At this time, the fibers in the right repair snapped causing another drop (Figure D.17 and Figure D.19). For the remainder of the test, the bars at the right end continued to slip until the load reached 60% of the peak load. The midspan deflection was 0.656 in. at the end of the test. Figure D.18 and Figure D.20 show the right support with the repair removed.

Figure D.16: Flexural crack at mid-span of Beam N-R1-S (Side A)

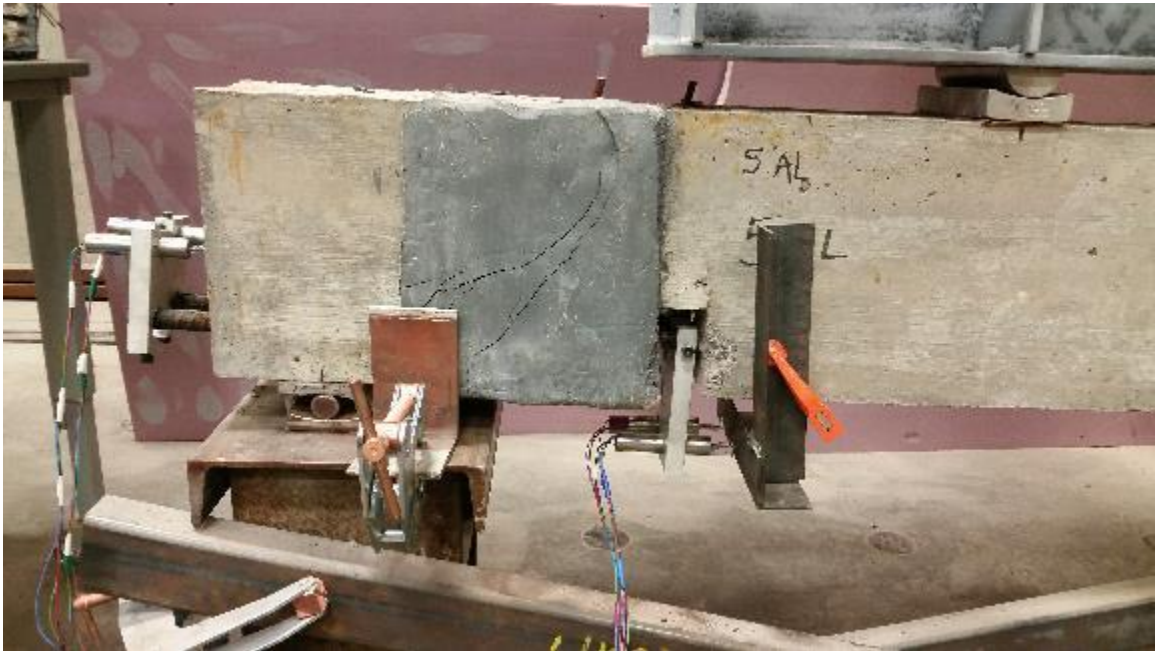
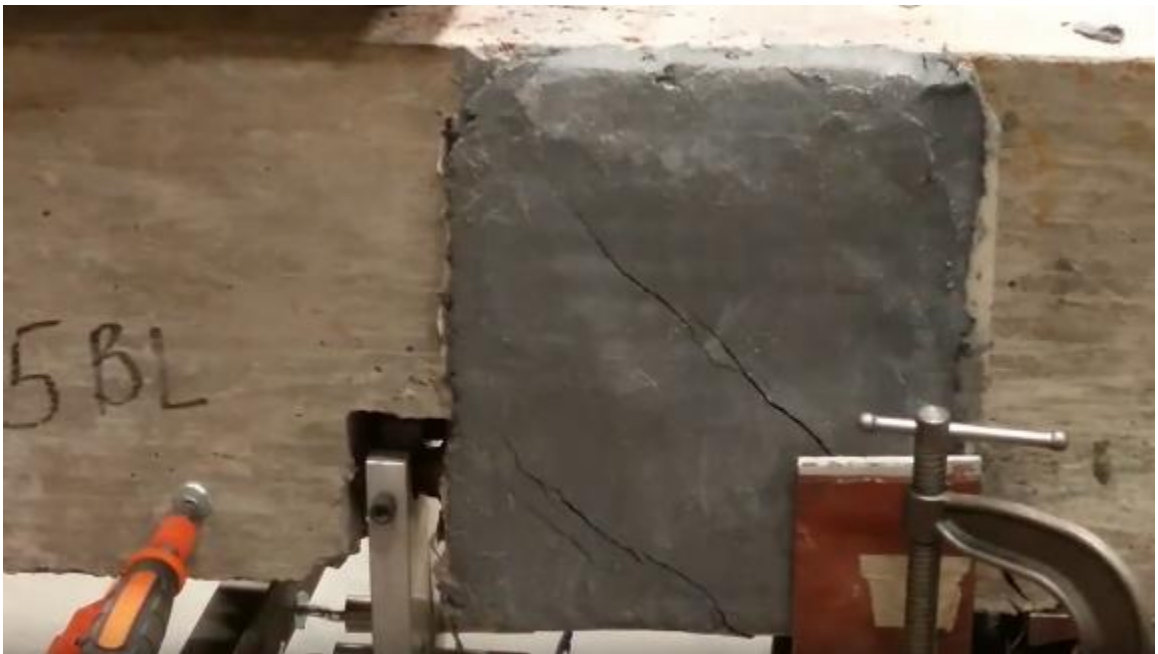
Figure D.22: Shear/splitting bond failure at left support of Beam H-R1-S (Side A)

Figure D.23: Shear/splitting bond failure at left support of Beam H-R1-S (Side B)

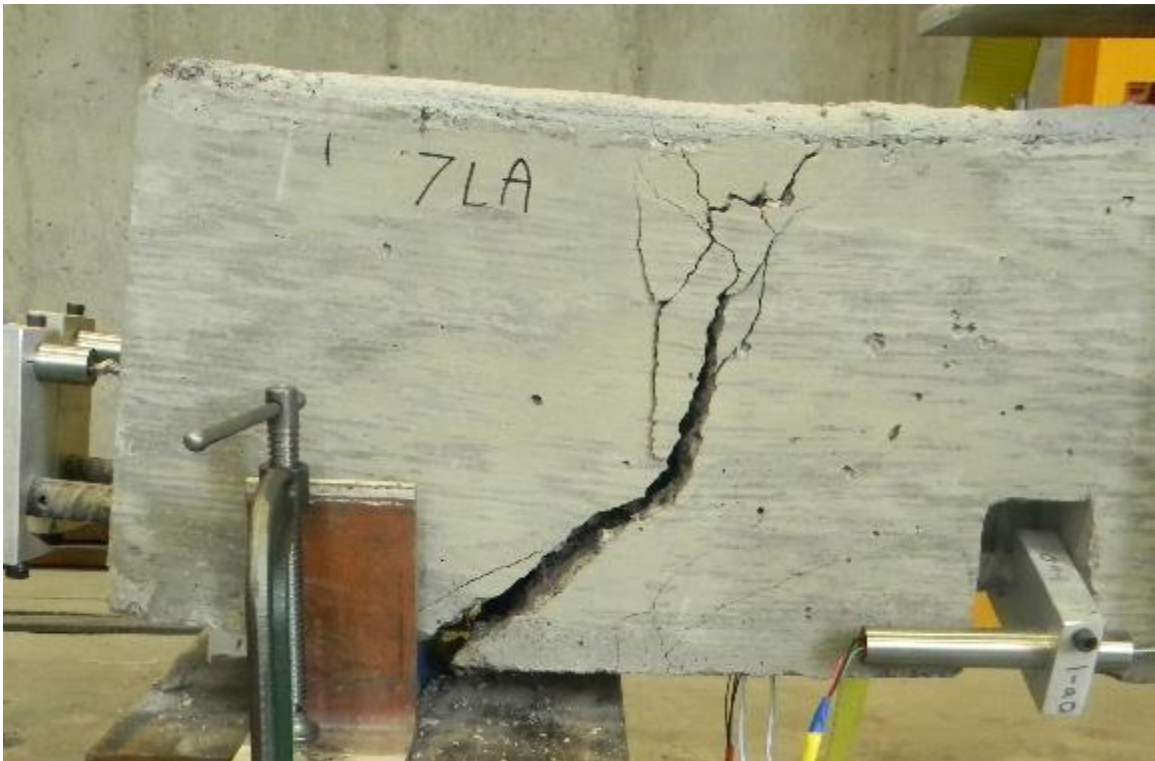
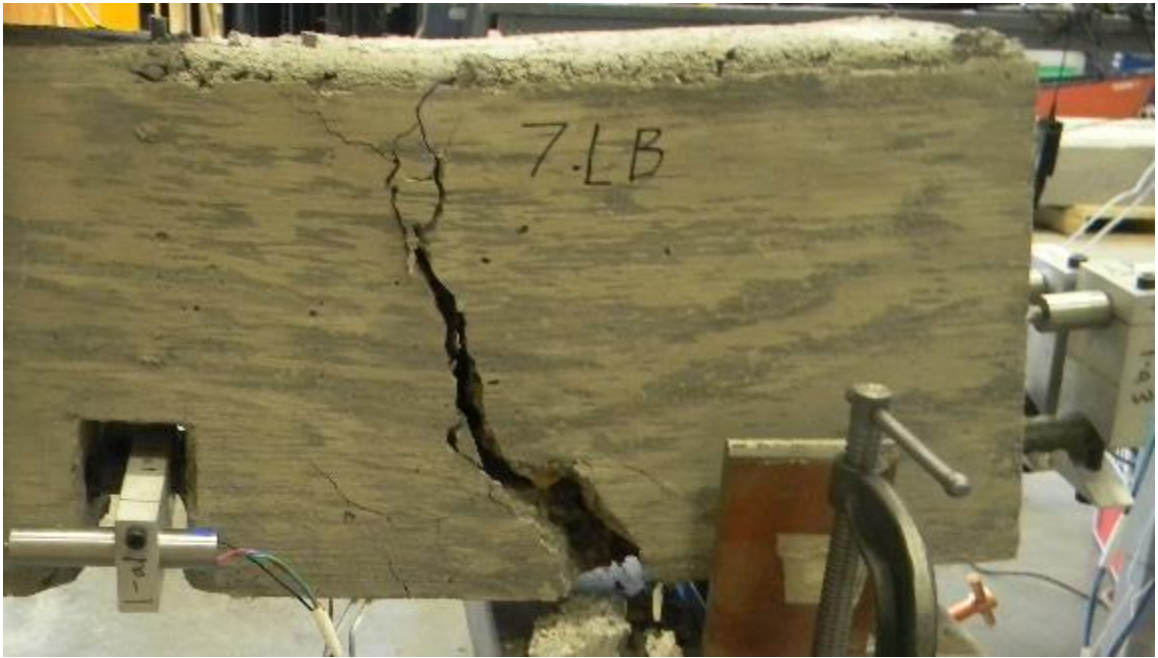
Beam N-U-F-2 was fatigued using a load range of 10.86 kips, which was 66% of the static capacity. This beam failed at 29,931 cycles. At the start of the test, a flexural crack formed to the right of midspan. A shear crack near the left support caused the beam to fail (Figure E.1 and Figure E.2). The concrete lugs were still intact, which indicates a splitting bond failure (Figure E.3). The concrete cover remained intact after failure, but the crack size prevented the development of a sufficient bond between the reinforcement and the concrete. No damage occurred near the right support.

Figure E.1: Failure at left support of Beam N-U-F-2 (Side A)

Figure E.2: Failure at left support of Beam N-U-F-2 (Side B)

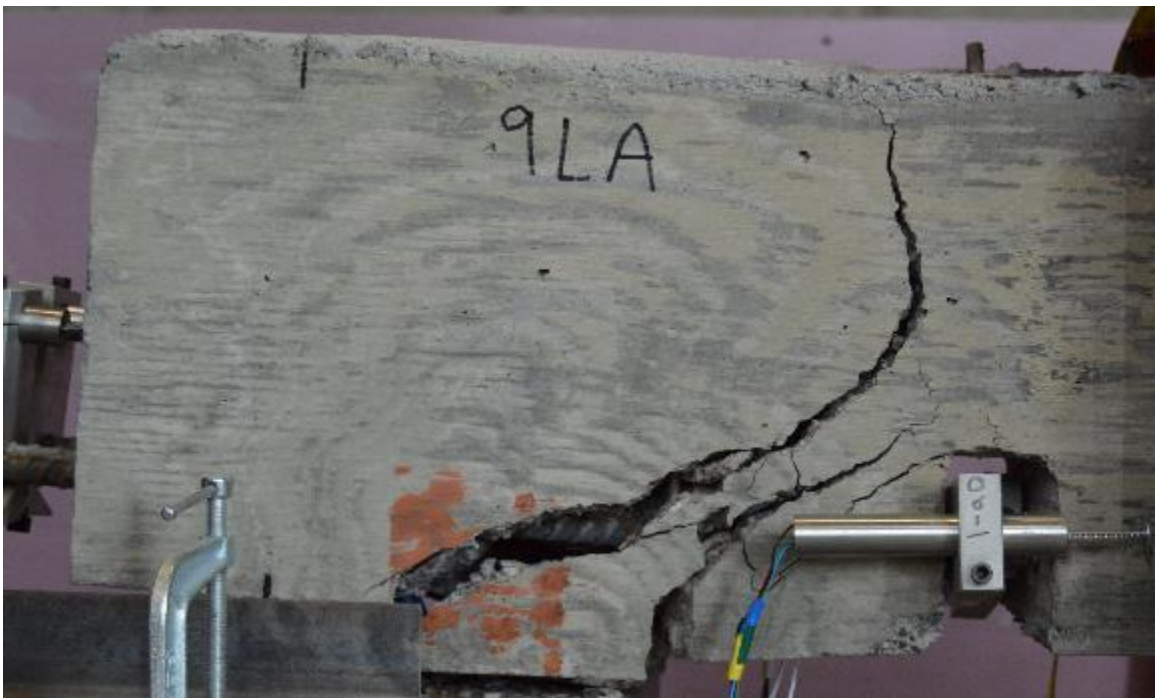
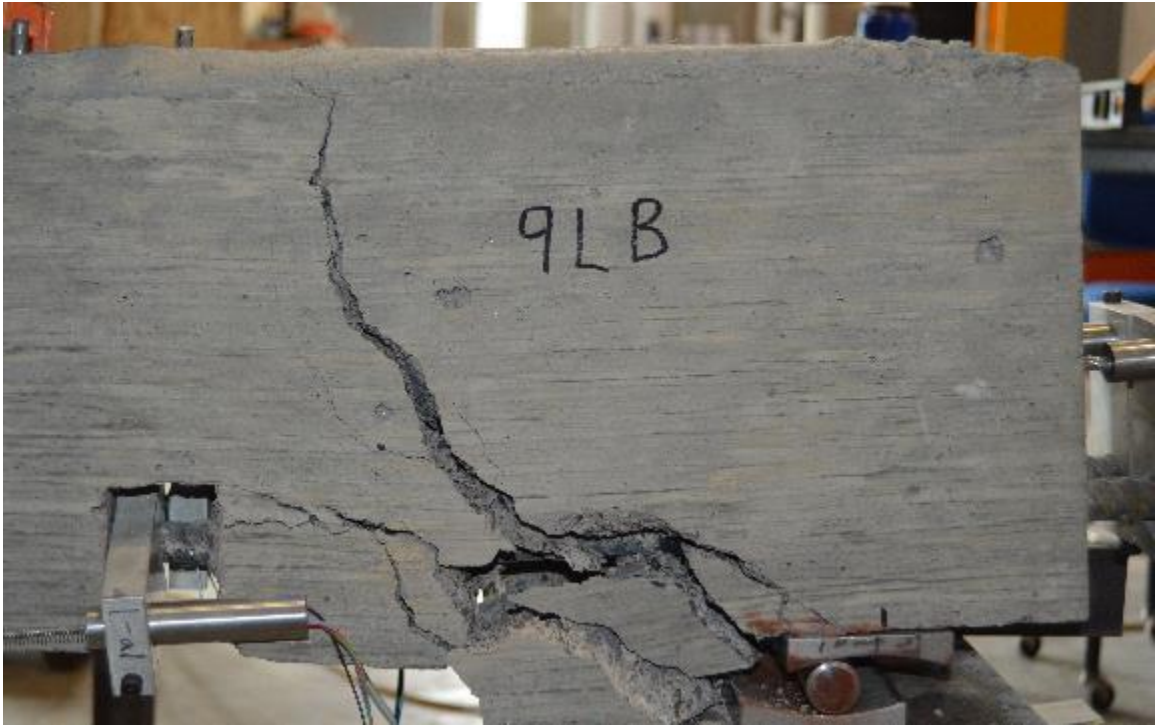
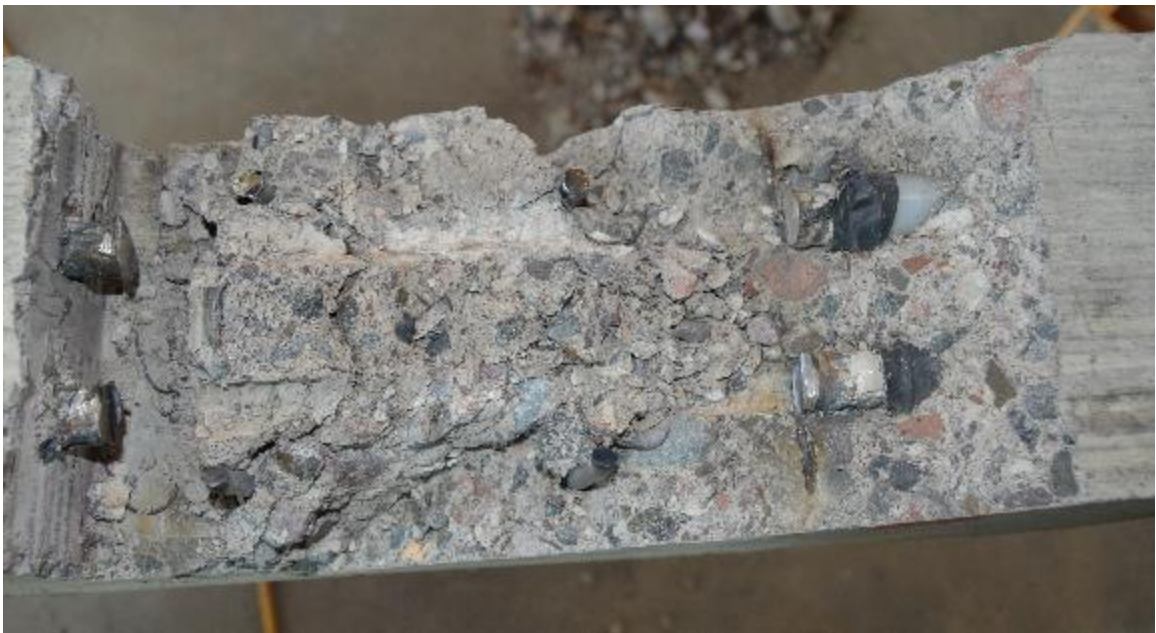
Beam N-U-F-3 was fatigued using a load range of 10.69 kips, which was 65% of the static capacity. This beam failed at 227,123 cycles. At the start of the test, a flexural crack formed at the left of midspan. A second flexural crack formed below the right loading point during the test. The crack at midspan continued to grow throughout the test, but the crack below the right loading point grew insignificantly. Towards the end of the test a third flexural crack formed on side B near the first midspan crack. A combination shear/bond failure occurred near the left support (Figure E.4 and Figure E.5). As the shear crack, grew to the top of the beam, the concrete cover below the bars detached caused a loss of bond. Figure E.6 shows the concrete after the reinforcement is removed. On side B, there was some crushing of the concrete keys. The rest of the area was destroyed in the failure.

Figure E.4: Failure at left support of Beam N-U-F-3 (Side A)

Figure E.5: Failure at left support of Beam N-U-F-3 (Side B)

Figure E.6: Beam N-U-F-3 concrete keys. Top is Side B and bottom is Side A.

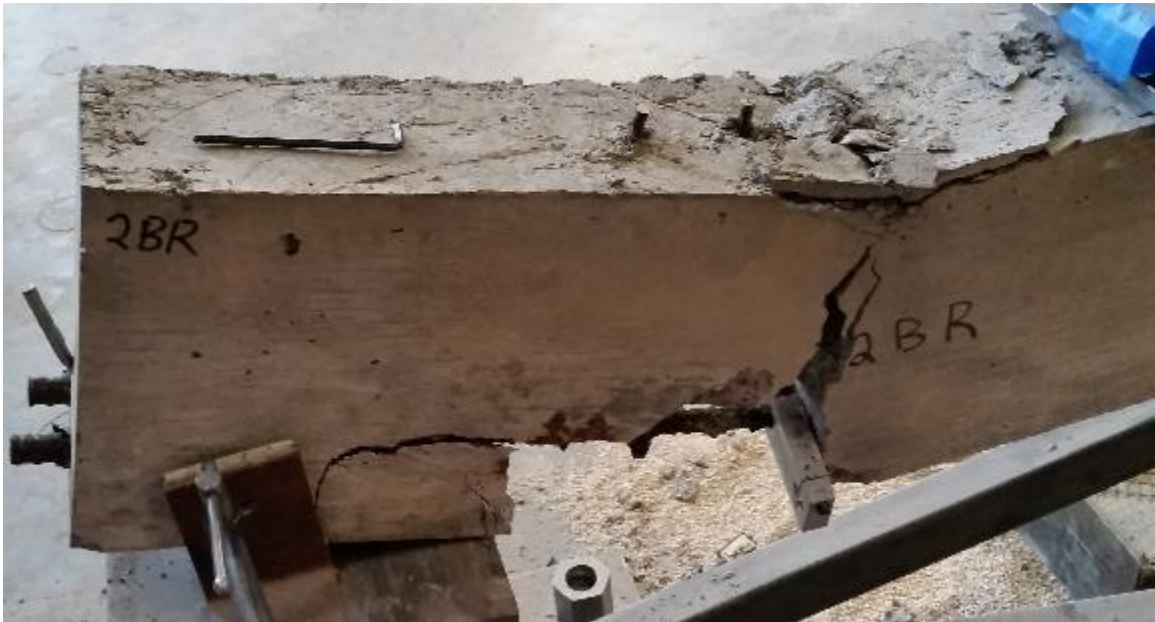
Figure F.2: Failure at right support of Beam H-U-F-1 (Side B)

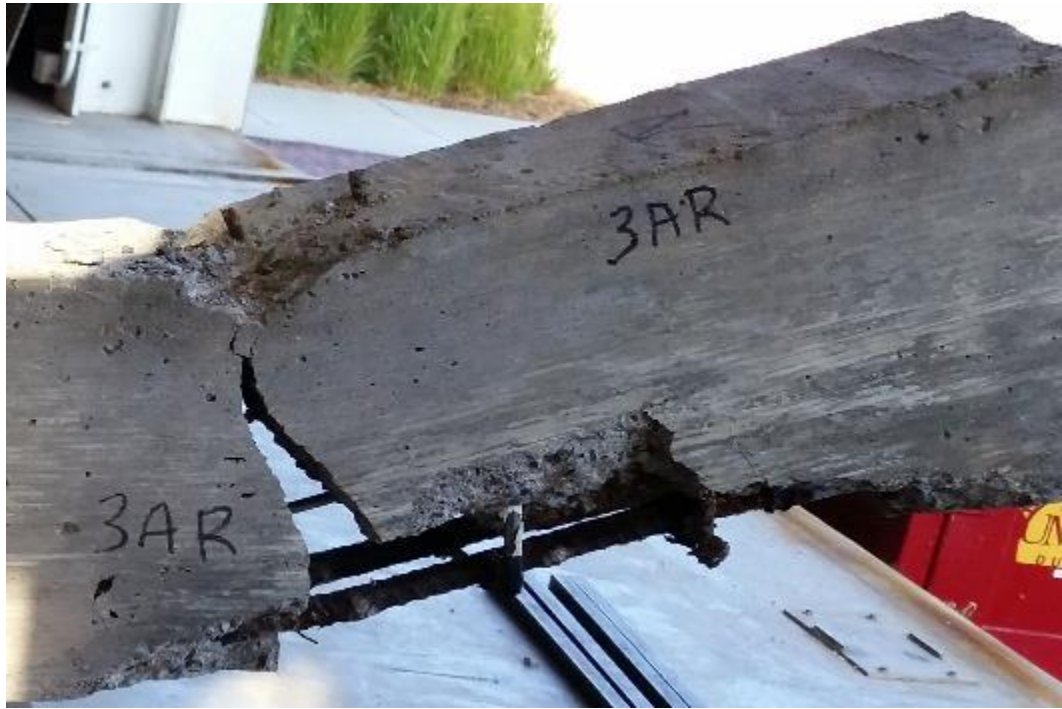
Beam H-U-F-2 was fatigued using a load range of 8.43 kips, which was 51% of the static capacity. The beam failed due to a power outage, so the results were inconclusive. A flexural crack formed at the right of center at the start of the test. A second fatigue crack formed below the left loading point. The power went out some time into the test causing a large force to be applied to the beam, which resulted in failure. This failure included a flexure failure at midspan and a combination shear/bond failure at the right support. At midspan there was concrete crushing of the compression zone. A similar crushing occurred above the right notch. At the right support, there was a loss of concrete cover below the bars and a sharp shear crack towards the center. No damage occurred near the left support.

Figure F.3: Failure at right support of Beam H-U-F-2 (Side A)

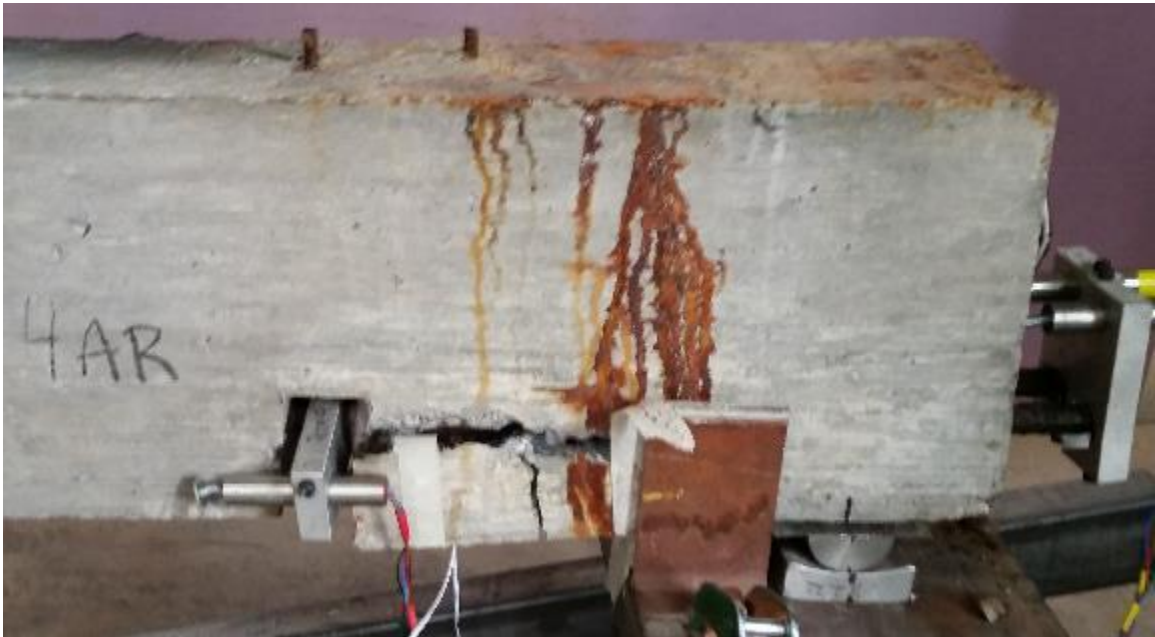
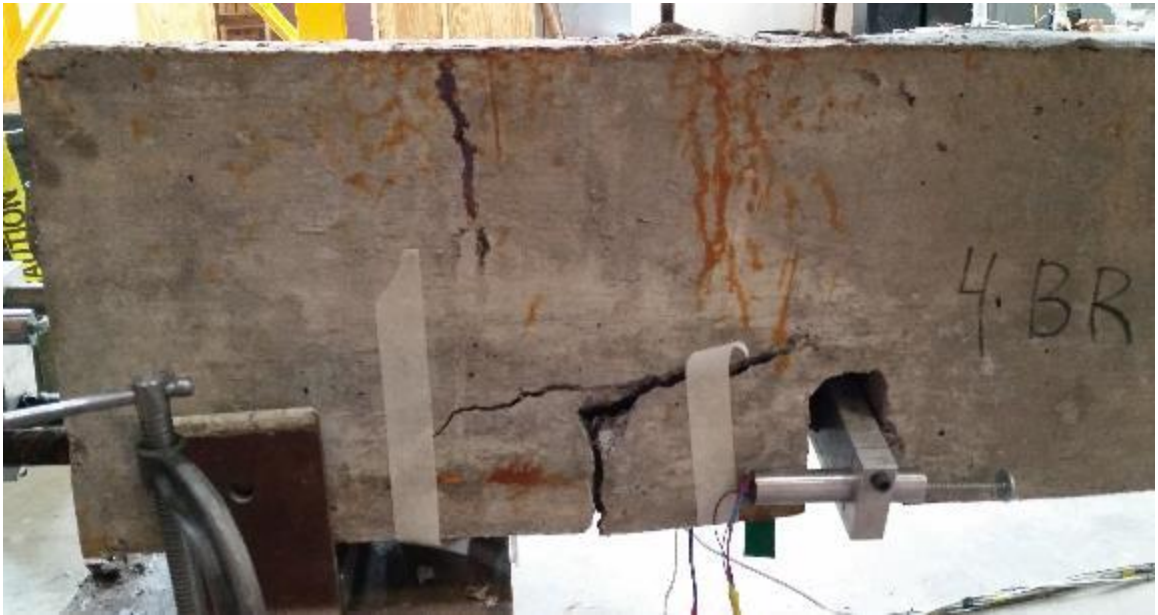
Beam H-U-F-3 reached one million cycles when fatigued using a load range of 8.43 kip (51% of static capacity). The beam failed prematurely due to a controller accident when tested at 8.98 kip (55% of static capacity). A flexural crack formed at the right of center at the start of the test. During the second test, the controller was accidentally turned off which caused a large force to be applied to the beam, which in turn caused the beam to fail. This occurred at around 520,000 cycles. The loss of concrete cover below the bars occurred at the right of the beam.

Figure F.5: Failure at right support of Beam H-U-F-3 (Side A)

Figure F.6: Failure at right support of Beam H-U-F-3 (Side B)

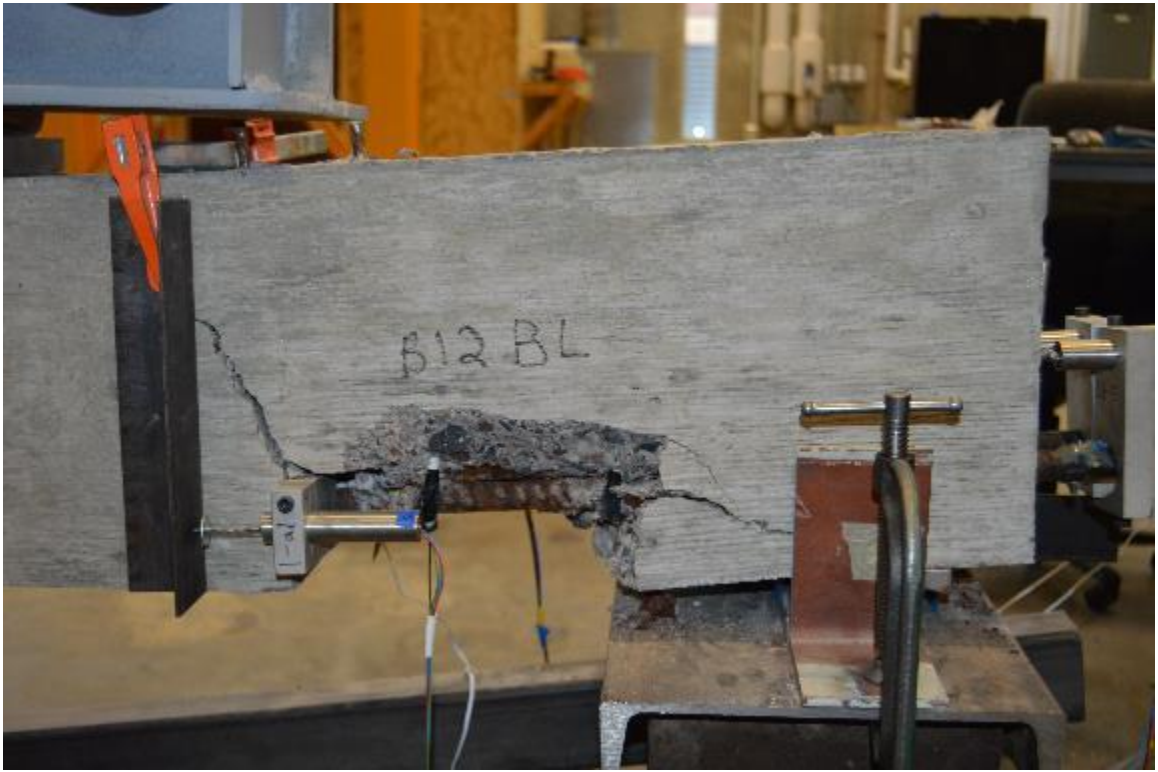
Figure F.8: Failure at left support of Beam H-U-F-4 (Side B)

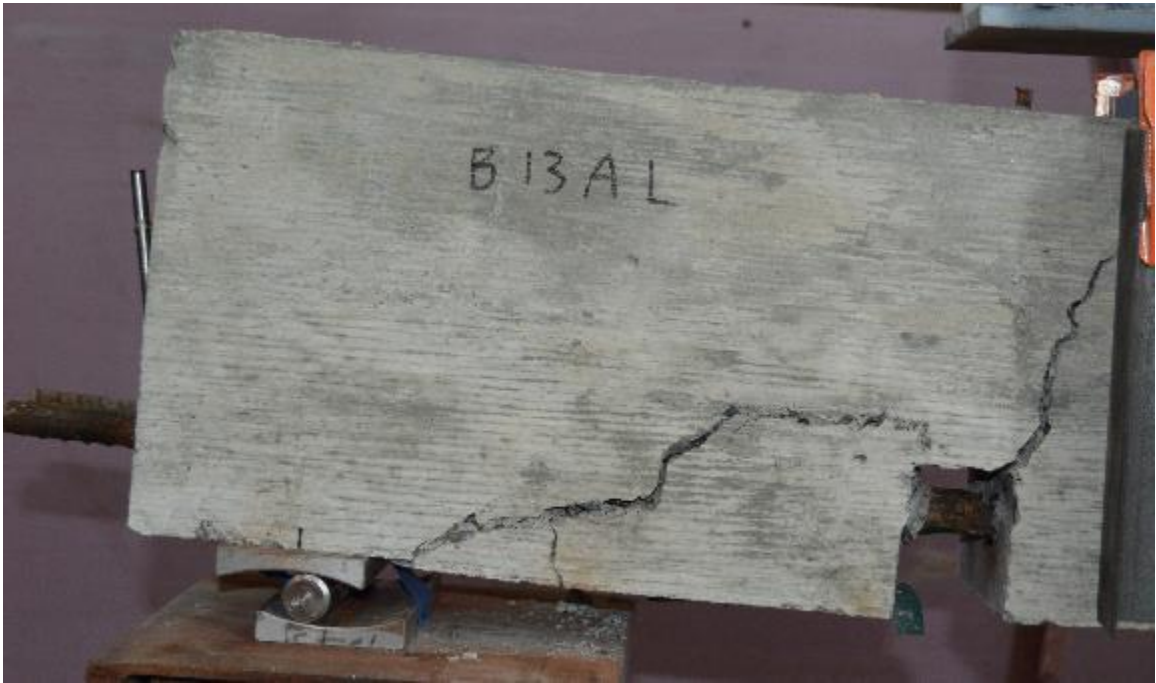
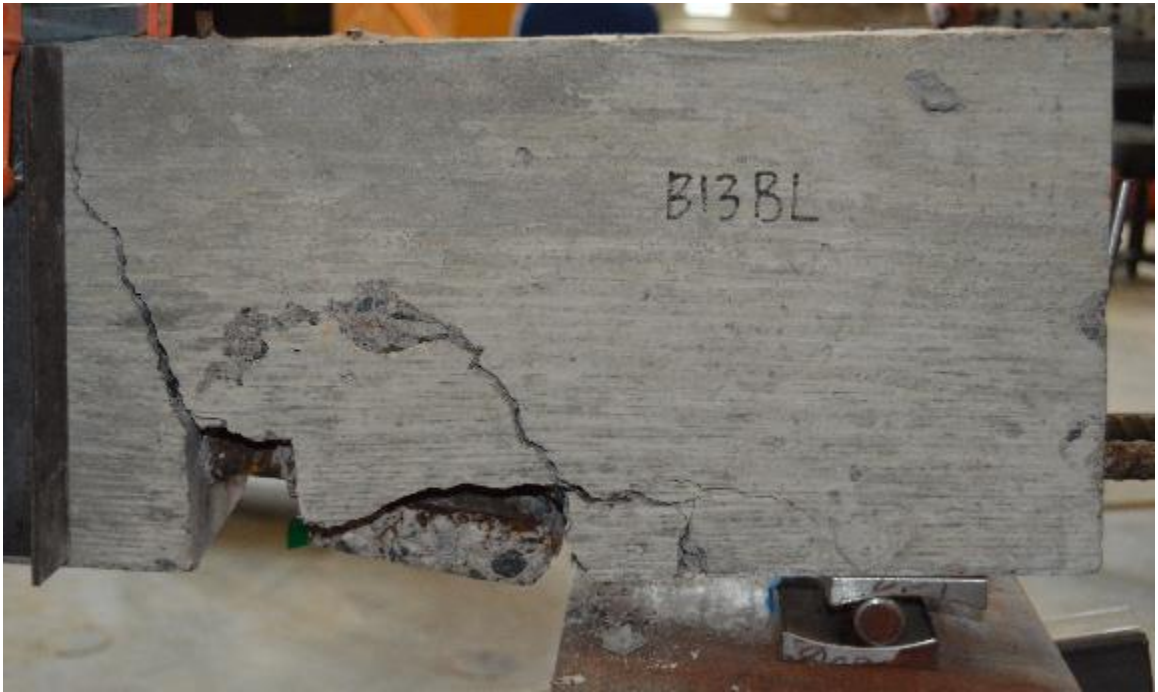
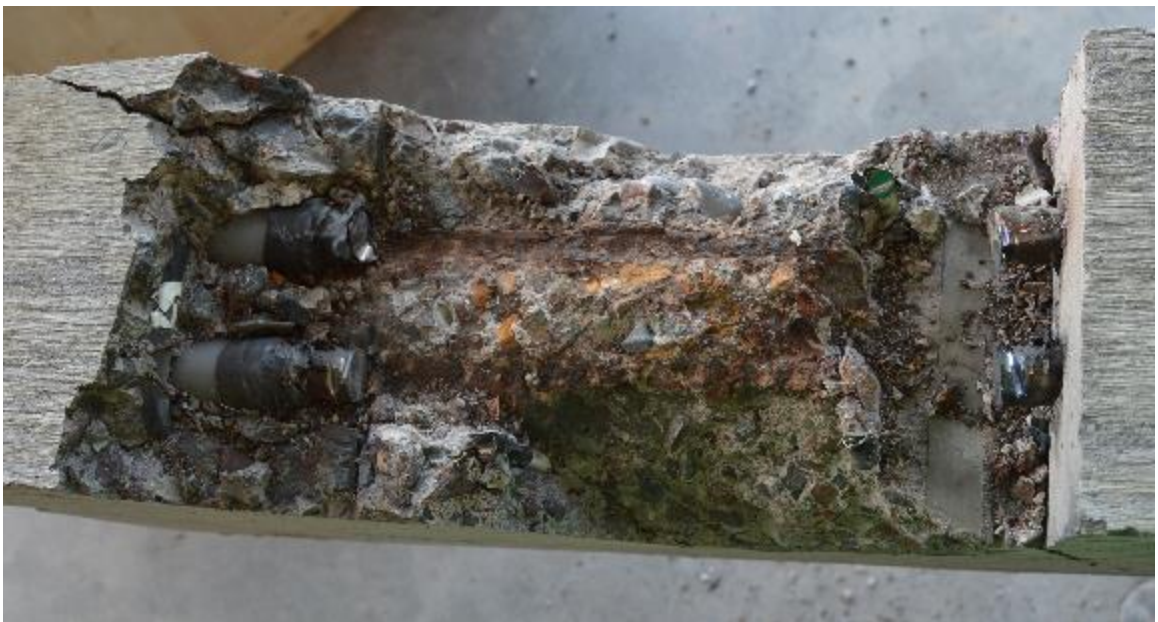
Beam H-U-F-5 was fatigued using a load range of 8.84 kips, which was 88% of the static capacity. The beam failed at 65 cycles. A flexural crack formed at the right of midspan at the start of the test. The bond of the reinforcement was lost at the left end of the beam shortly after the test began resulting in a failure. The concrete cover beneath the bars was pushed off by growing cracks near the support. No failure occurred at the right end of the beam.

Figure F.10: Failure at left support of Beam H-U-F-5 (Side A)

Figure F.11: Failure at left support of Beam H-U-F-5 (Side B)

Figure F.12: Beam H-U-F-5 concrete keys. Top is Side A and bottom is Side B.

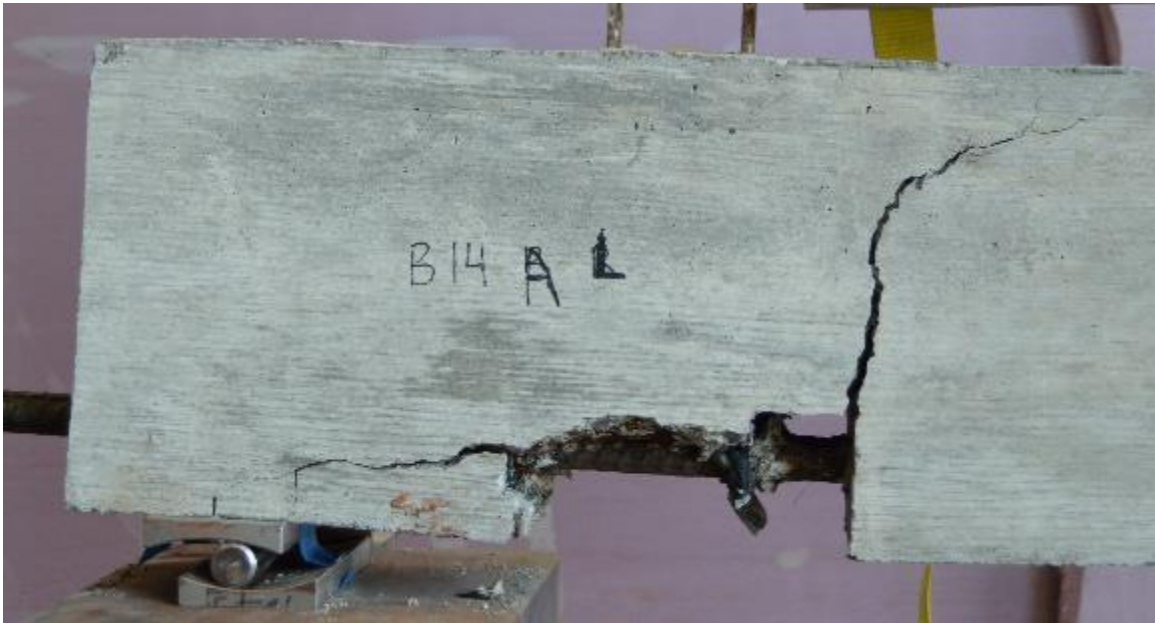
Beam H-U-F-6 was fatigued using a load range of 8.41 kips, which was 83% of the static capacity. The beam failed at 88 cycles. A flexural crack formed at the right of center at the start of the test. A crack propagated from the corner of the left pocket at a sharp angle towards the center of the beam. At the same time, the crack from the corrosion at this end increased in width until the bottom cover fell off. This loss of bond caused the bars at this end to slip and fail the beam with a splitting bond failure.

Figure F.13: Failure at left support of Beam H-U-F-6 (Side A)
